MEMORANDUM

Project: Gold King Interim Water Treatment Plant (IWTP)
Location: Gladstone, Colorado
Prepared for: Emergency Response Unit – US EPA Region 8

Reporting Period: Mar 7 – Mar 14
Report No.: 12

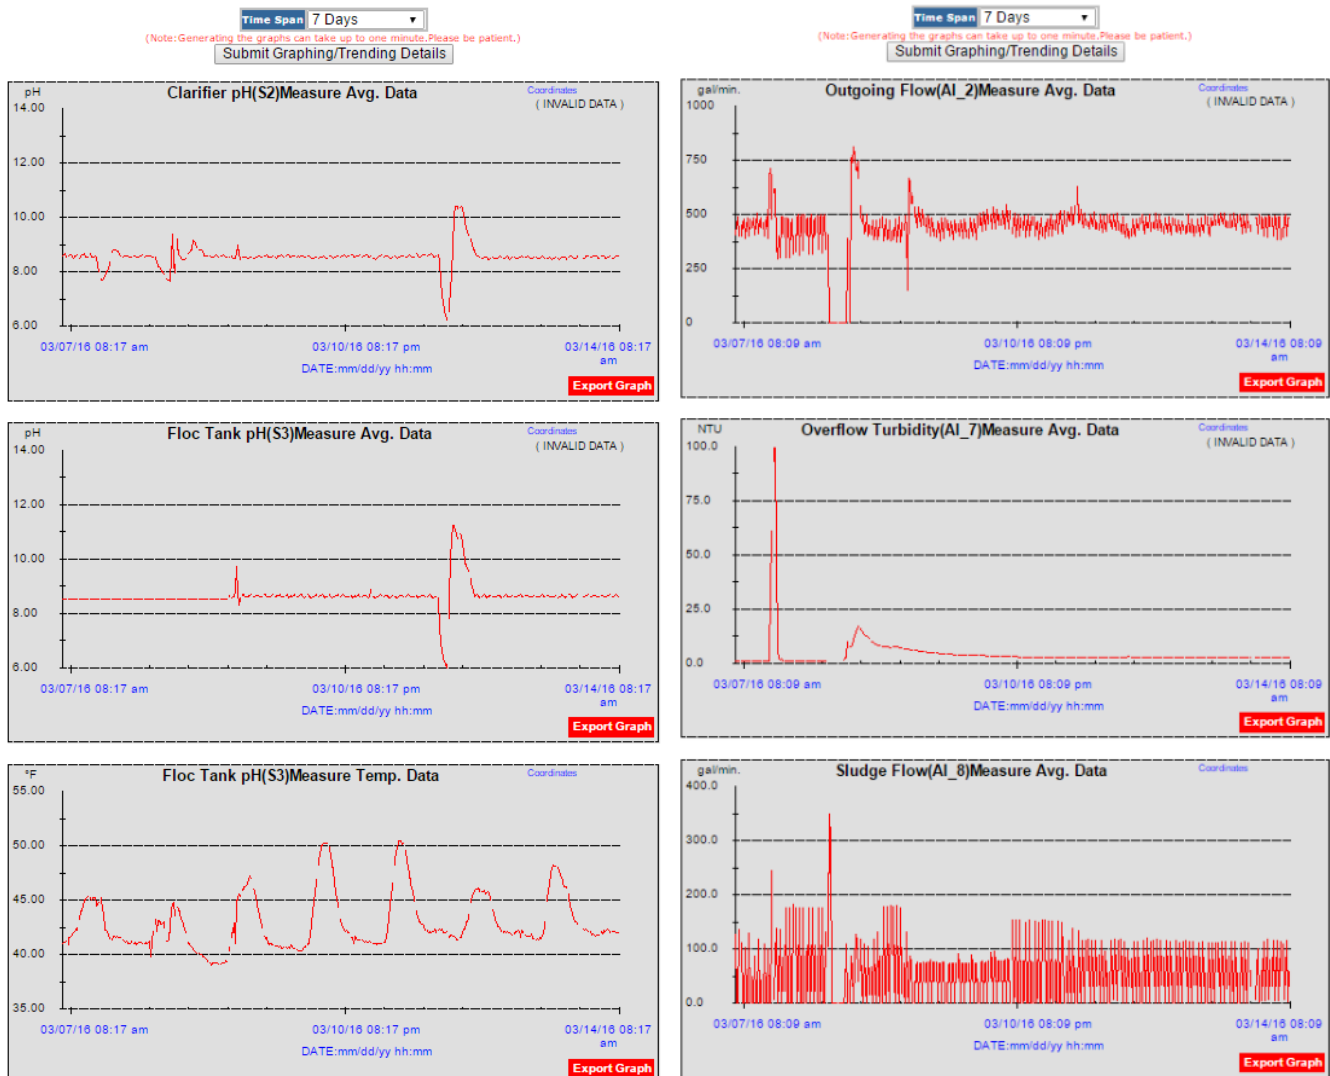
- The following graphs provide trending information collected by datalogging equipment during the previous 7 days. These dataloggers collect control information from the Lime Circuit (left) and Flow Circuit (right) Programmable Logic Controllers (PLCs) at the Gold King IWTP. Over the reporting period (3/7/16 – 3/14/16 inclusive) Alexco treated 4.33 million gallons at an average flow rate of 430 gpm with all discharged treated water leaving the 12" HDPE pipeline.

- Please note: Several days each week, the Alexco operators check the pH at both the flocc tank and clarifier discharge. During this time, the probe is placed in vinegar (acid), and three pH buffers – 4, 7, and 10. While the probe is in the acid/buffer, the datalogger may capture one of those points for tracking purposes, which explains the occasional pH spikes seen on the graph.

- On 3/8/2016 Alexco shut-down the IWTP, retaining Gold King water in Ponds 1 and 2. During this shut-down the incoming 8" HDPE line was replaced with a 12" steel line, maintenance was performed on the clarifier, and a 3" knife-gate valve was installed at the sludge release flange on the clarifier. This shut-down is shown on the outgoing flow graph where the discharge rate dropped to zero for several hours.

- On 3/12/2016, at 1:30am, the 6" PVC pipe that funnels lime powder to the lime slurry tank became misaligned. Because make-up lime powder was not entering the lime slurry tank, the pH began to drop until an operator arrived at 4:30am and corrected the problem. The system then rebounded and overshot the pH set-point until equilibrium was re-established. The operators will secure the pipe so misalignment does not happen in the future.

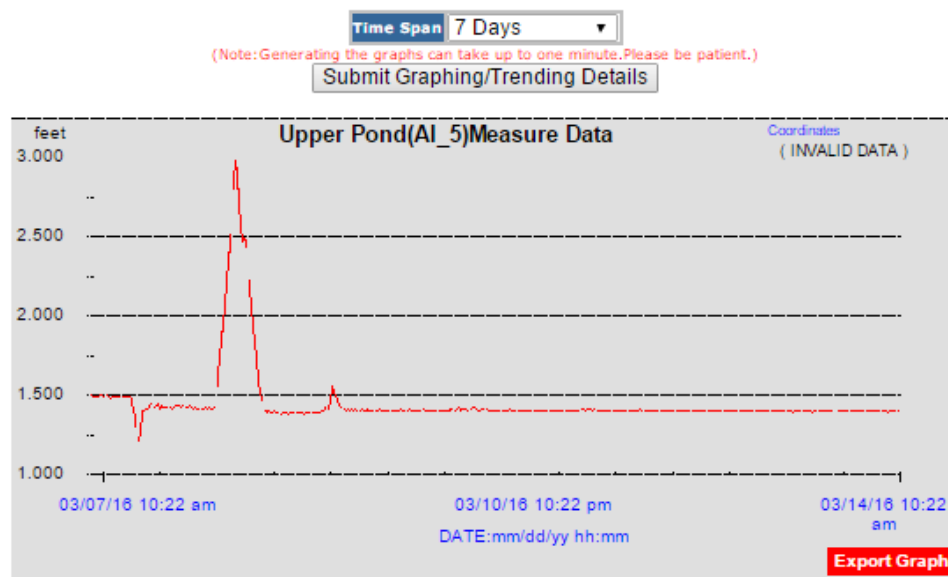
- On 3/7/2016 Alexco and EPA hosted a tour of the IWTP.
- On 2/22/2016, Alexco installed a solar-powered/wireless pressure transducer in the upper lined pond. This new system provides remote monitoring of Pond 2 levels. Since installation, the head on the pressure transducer has been steady at a little less than 1.5 feet, and the system responded accurately on 3/8/2016 when an operator shut-off the IWTP intakes and Pond 2 levels rose to roughly 3 feet. See Figure 2.

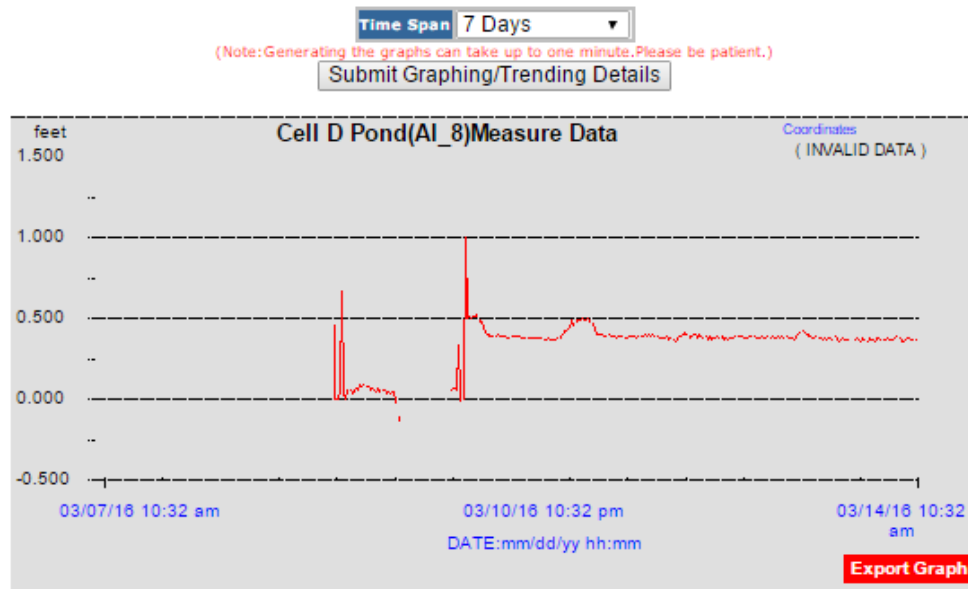
- On 3/9/2016, Alexco installed a second solar-powered/wireless pressure transducer near the berm that holds back water within Cell D. This new system provides remote monitoring of Cell D levels. If the levels in the Cell begin to rise, caused by a failure of the pumpback system, the local and remote Alexco personnel will be immediately notified. Since installation, the head on the pressure transducer has been steady at around 0.4 feet. See Figure 3.

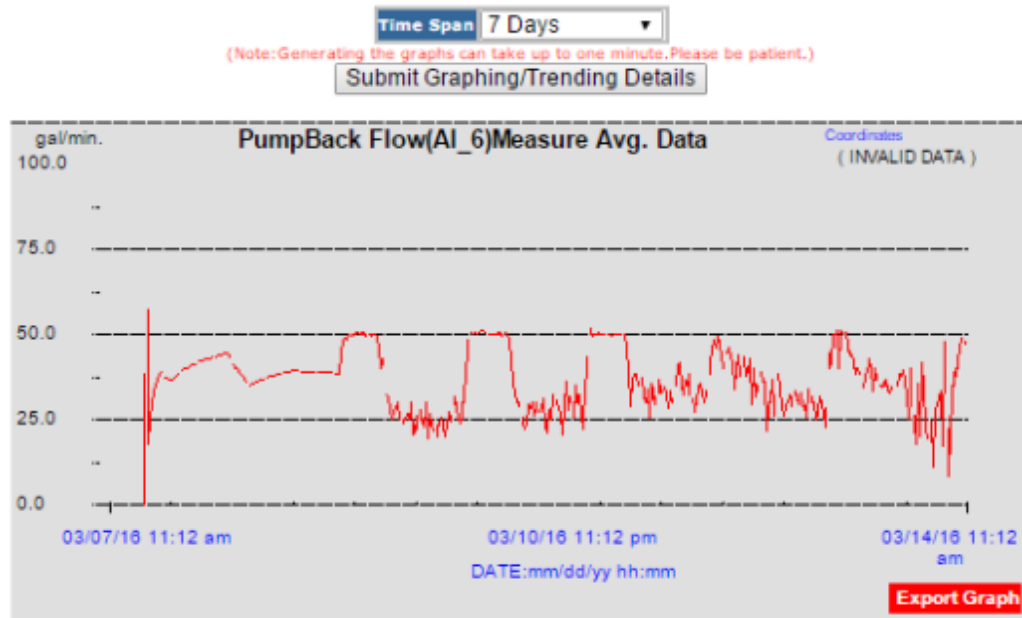
- On 3/9/2016, Alexco and ER made improvement to the berm that holds back water within Cell D. See Figure 3.
- On 3/7/2016, Alexco connected the pumpback flow meter to the PLC allowing for remote monitoring of the pumpback flow rates. In addition, alarms have been set so that if the flow drops below 10 gpm (pump failure) the local and remote Alexco personnel will be immediately notified.

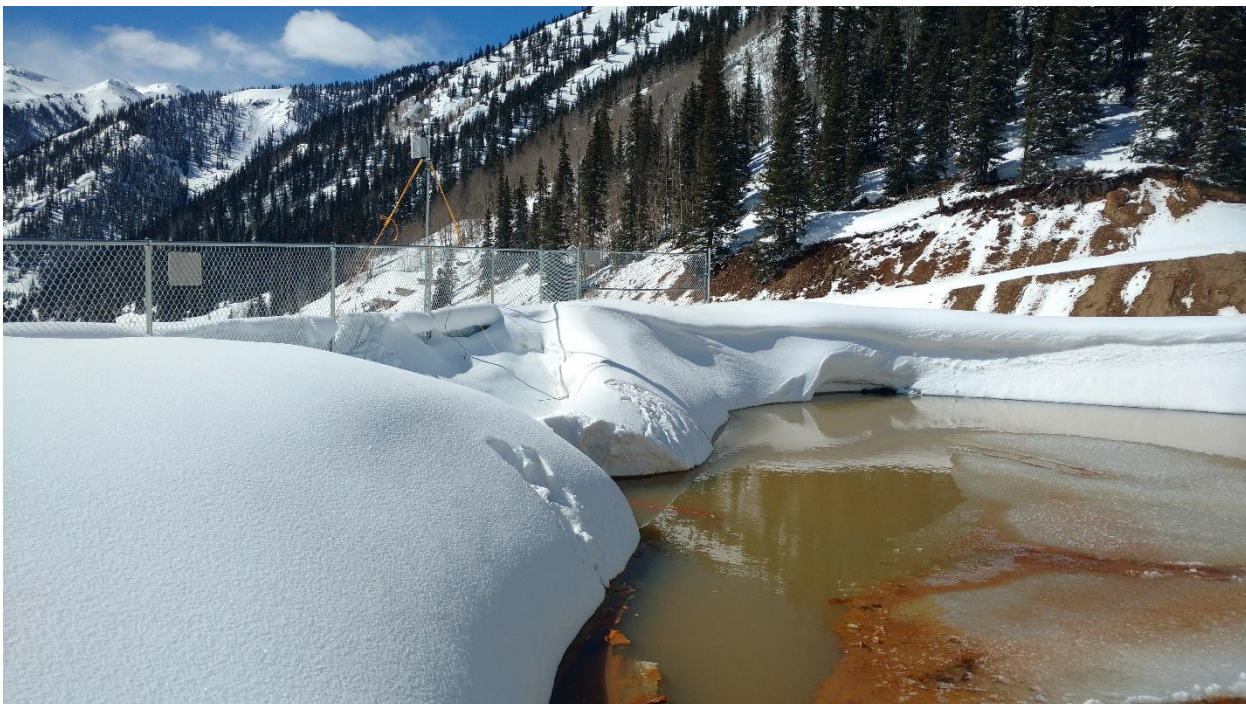
Figure 2: Solar panel and pressure transducer at Pond 2 – Taken on 3/8/2016

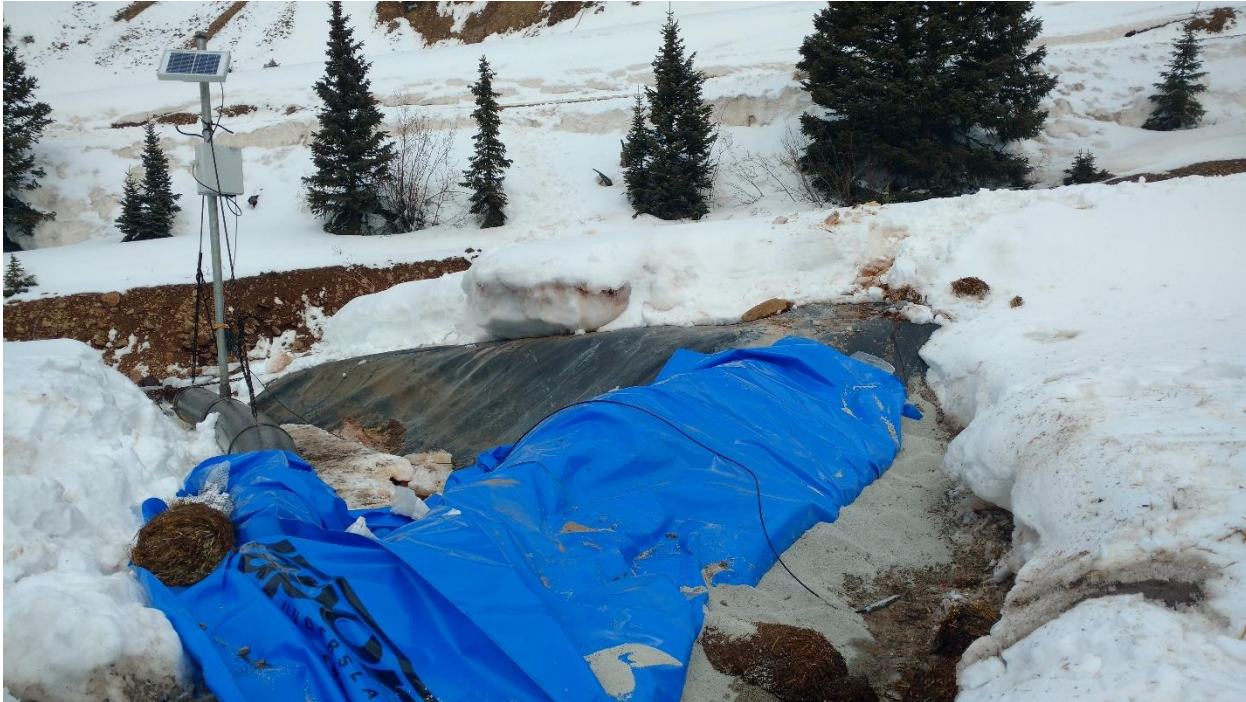
Figure 3: Solar-powered pressure transducer near the discharge point of Cell D – Taken on 3/9/2016
